## TIHONET POND NO. 2 DAM

MA 00030

# PHASE I INSPECTION REPORT NATIONAL DAM INSPECTION PROGRAM

JULY 1981

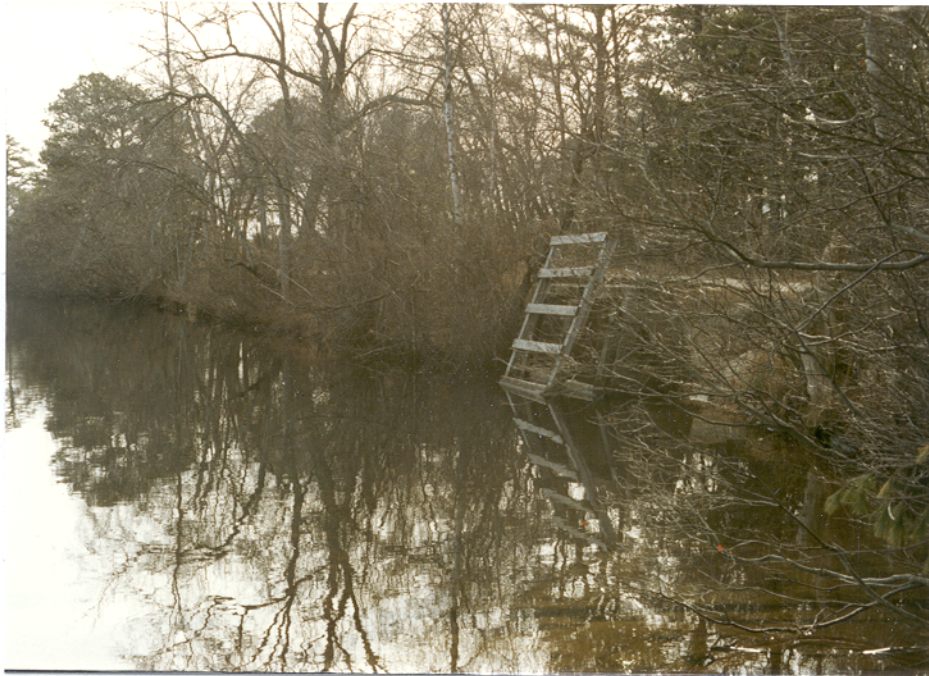
The right spillway includes a concrete intake structure controlled by stoplogs which is in good condition (Photo # 1 & # 2). Flow from the intake structure passes into 4.2 ft. wide by 3.6 ft. high concrete culverts which pass through the dam and exits at the downstream toe. The interior of the box culverts were visually examined and are in good condition (Photo # 8). Stoplogs are in fair condition. Some erosion of the embankment has occurred near the downstream toe adjacent to the concrete box culvert and at the upstream intake structure.

Photo # 1 Right Intake Structure and Upstream Dam Face

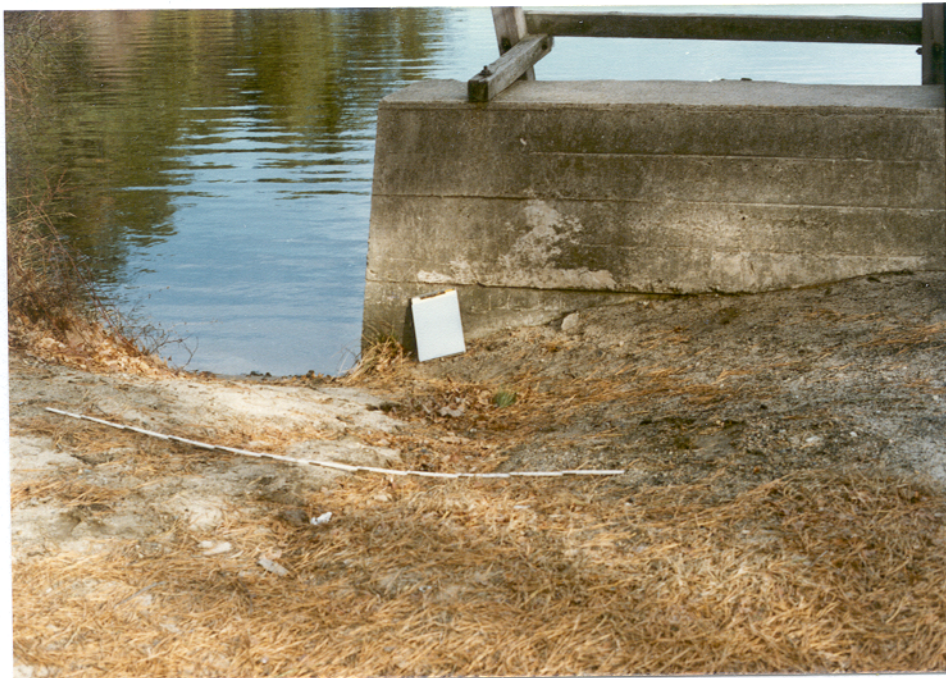
Photo # 2 Erosion near Right Intake Structure  
(Rule extended 6 feet)

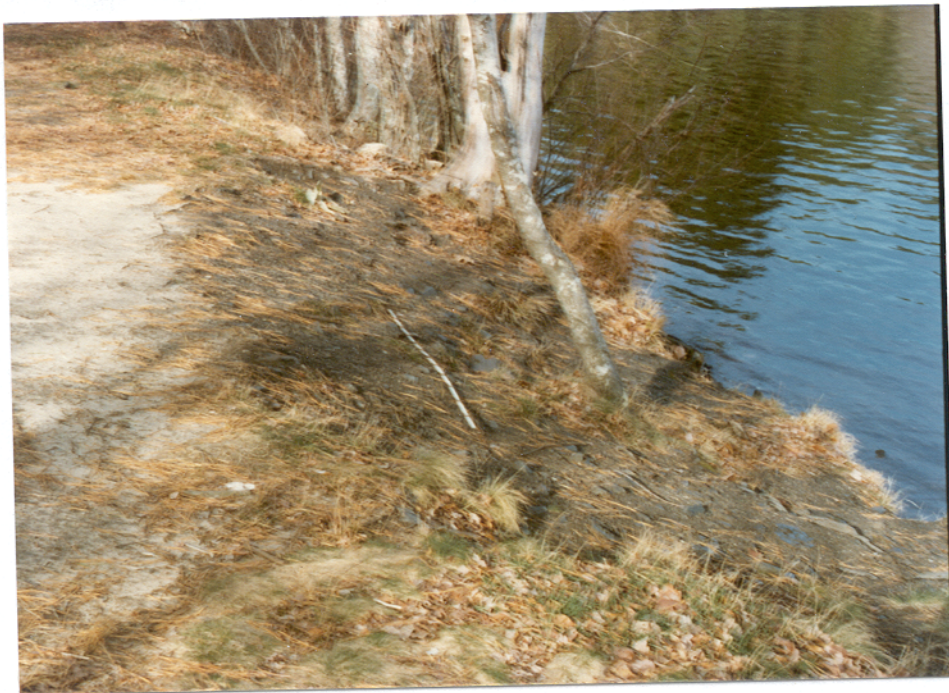
Photo # 3 Erosion at Upstream Dam Face  
(Rule extended 6 feet)

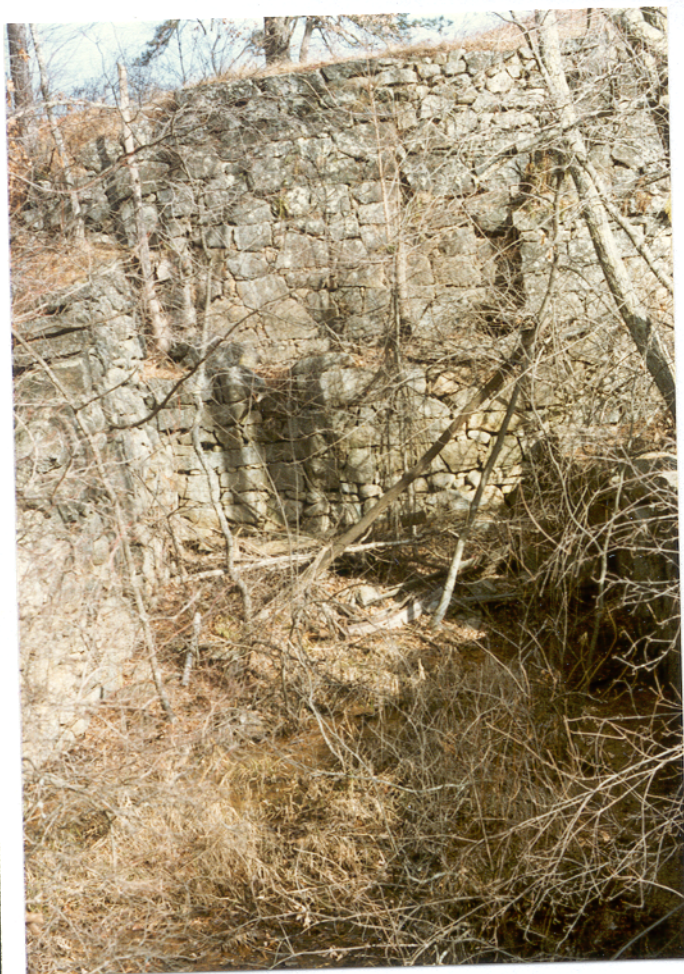
In the vicinity of the old plugged outlet, the downstream soil slope has been replaced with a vertical stone masonry wall for the full height of the dam (Photo # 4). Most of the wall is mortared except for a 50 ft. unmortared section near the plugged outlet. The wall has tilted up to 6 inches in the downstream direction (Photo # 5). Portions of the wall appear to have been repointed recently.

Photo # 4 Masonry wall and channel  
at Plugged Outlet

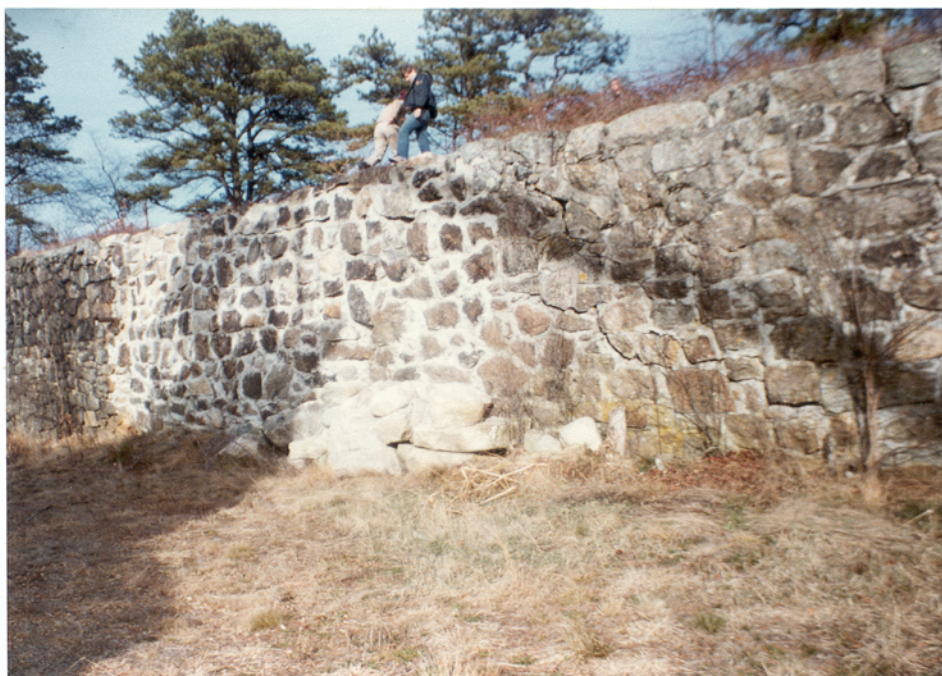
Photo # 5 Bulged wall at Downstream Face

Recommendations include that the owner engage the services of a qualified registered engineer to specify and oversee the removal of trees and root systems on the embankment, investigate the cause of wet areas at the toe of the dam embankment, design and oversee construction of erosion protection for the upstream face and crest of the dam, investigate the stability of the bulged area at the downstream masonry wall.

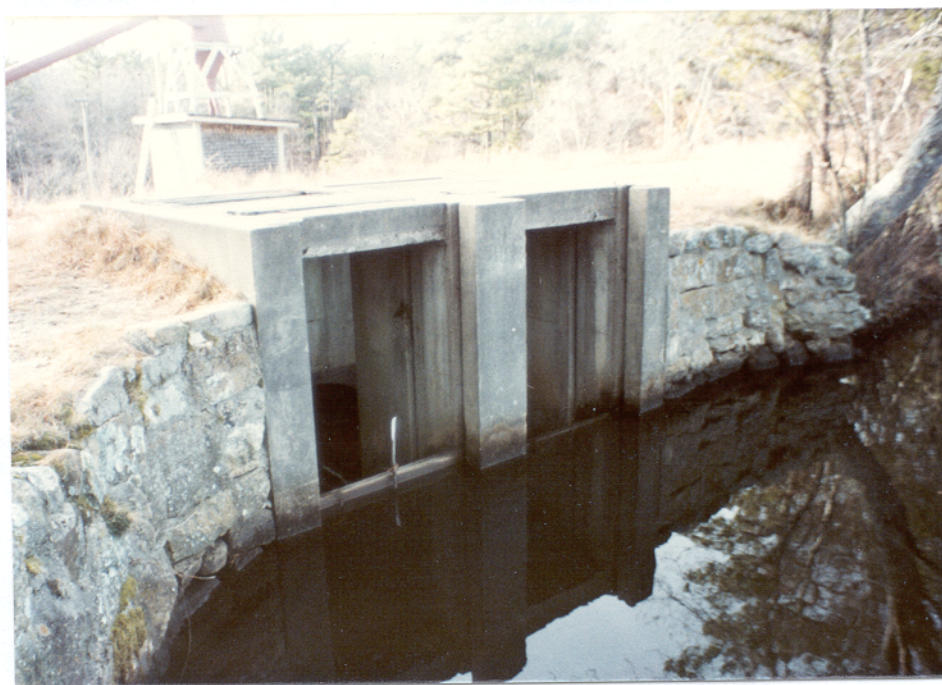
The left spillway is located near the left end of the dam and consists of stoplogs in a concrete intake structure and a 5 ft. diameter iron pipe which empties into a channel of approximately vertical cut stone masonry block training walls (Photos # 6 & # 7). The concrete intake structure is in fair condition. Planking over access panels to the intake is rotted in places. Stoplogs were in fair condition.

Photo # 6 Left Outlet - Concrete Intake Structure

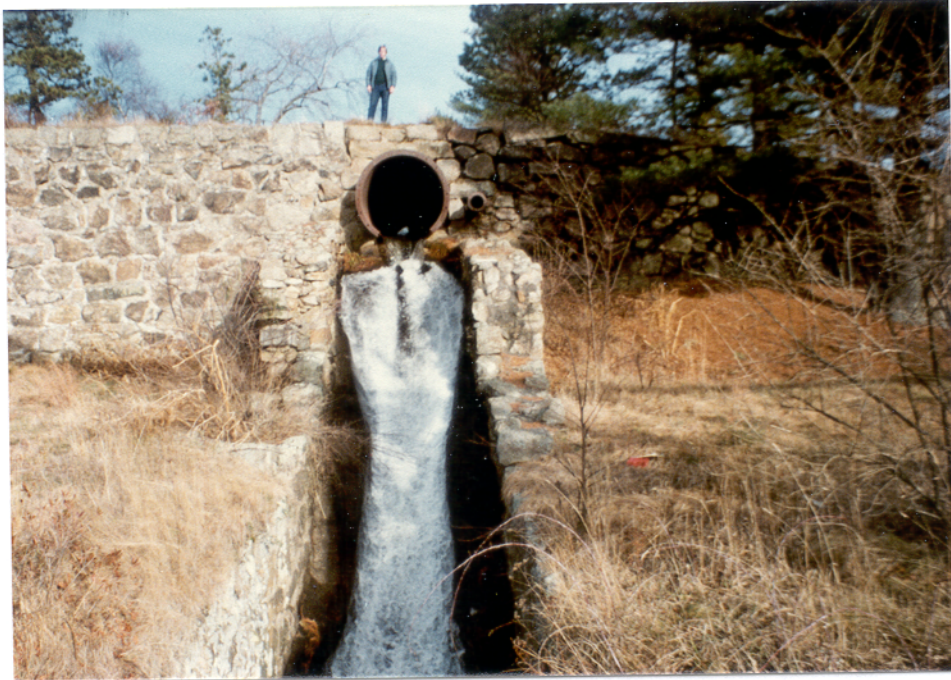
A 22 inch diameter cast iron pipe was noted next to the 5 ft. diameter pipe (Photo # 7). The purpose of this pipe could not be determined.

The outlet channel for the left outlet is comprised of cut-stone masonry channel with approximately vertical training walls. The training walls are in fair condition with some indication of distortion and missing blocks. The flow falls from the iron pipe to this masonry channel then passes under a small wood plank foot bridge and joins an adjacent channel coming from the plugged outlet works.

Photo # 7 Left Outlet - showing 5 ft. Iron Pipe, 22 inch Iron Pipe and Downstream Channel

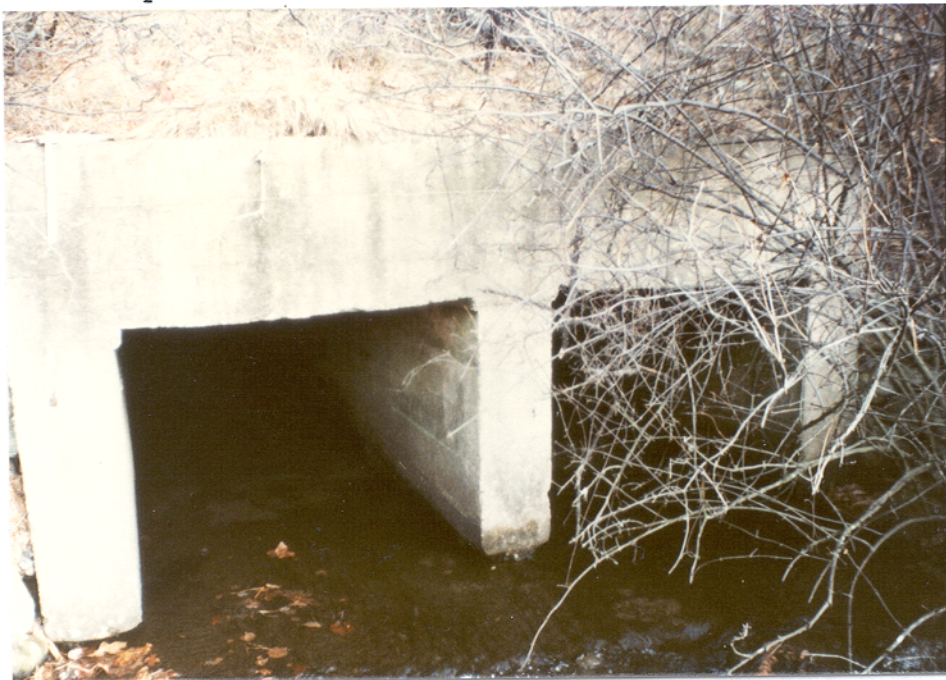
Photo # 8 Right Outlet - Downstream face of 3.6 ft. high Twin Box Culverts

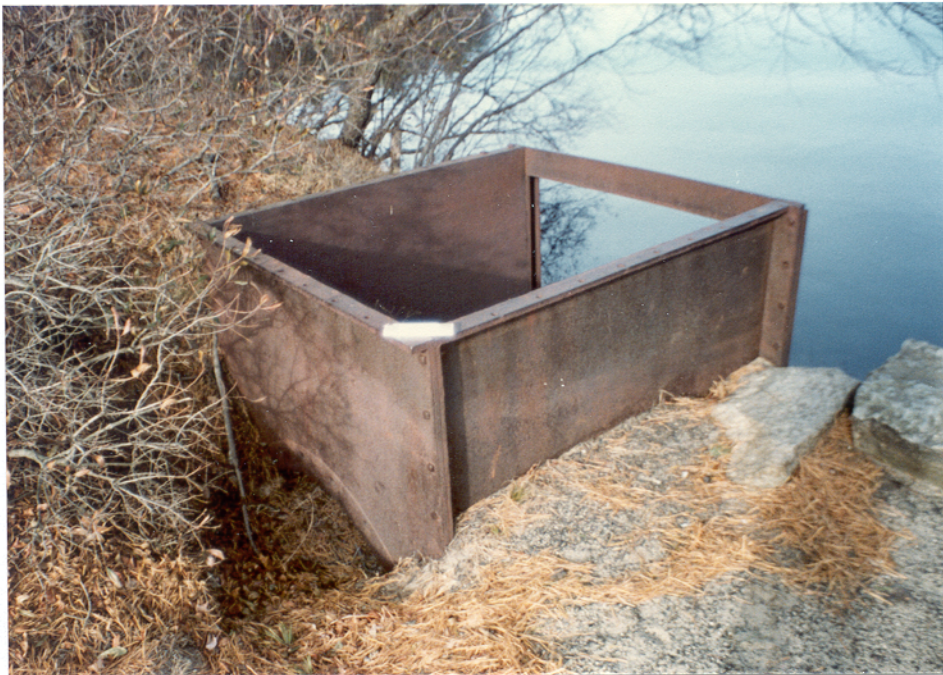
Photo # 9 Plugged intake of former outlet structure

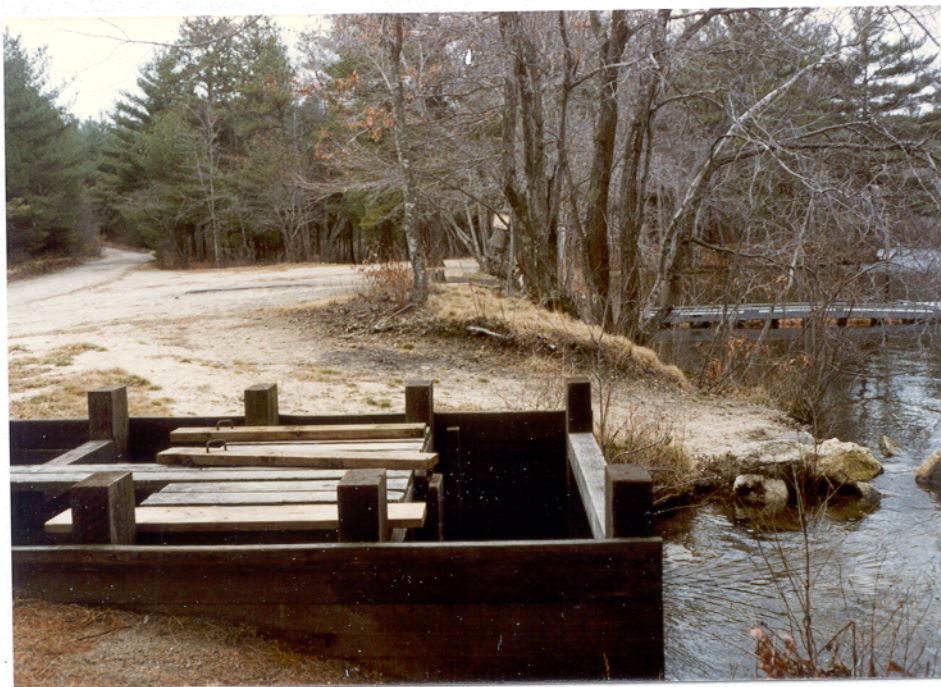
Photo # 10 Crest - Tihonet Pond #1 Dam

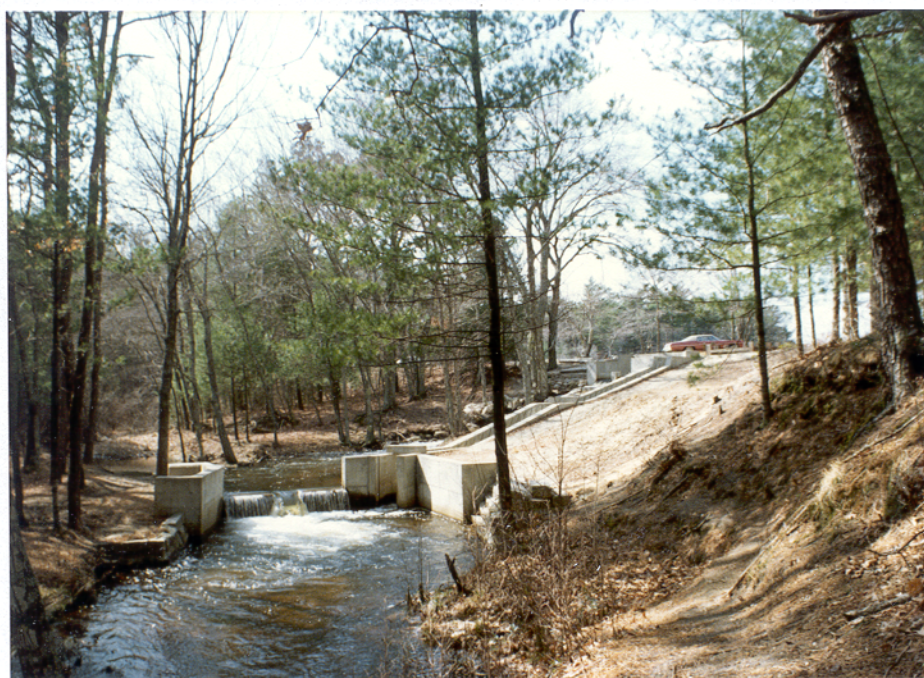
Photo # 11 Downstream Slope Tihonet Pond #1 Dam
